Collapse behaviour of a fire engineering designed single-storey cold- formed steel building in severe fires

Published in:
Thin-Walled Structures

DOI:
10.1016/j.tws.2019.04.046

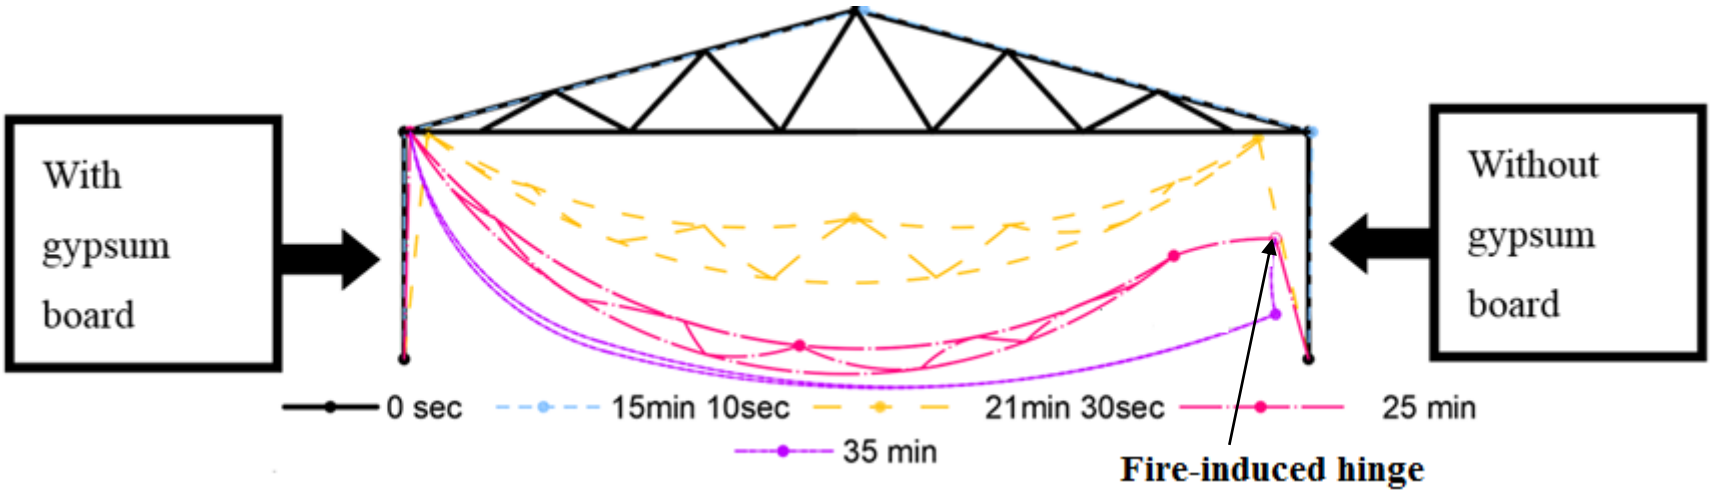
Fig. 7: Deformations of cold-formed steel cantilever wall/truss system

Fig. 7 illustrates the schematic collapse of central part of the structure, demonstrating displacement of the frame with time from ignition. The collapse mode was asymmetric with initial thermal expansion of the frame followed by an inward collapse at 622.5 °C, at a time of 21 min 30 sec from ignition. A fire-induced hinge was formed on the steel studs at a time of 22 min, allowing upper part to rotate around the hinge. This mechanism is referred to the snap-through buckling of steel studs. The location of fire-induced hinge was approximately located

on one third the length of wall stud. The snap-through mechanism was recorded at a time of 35 min.

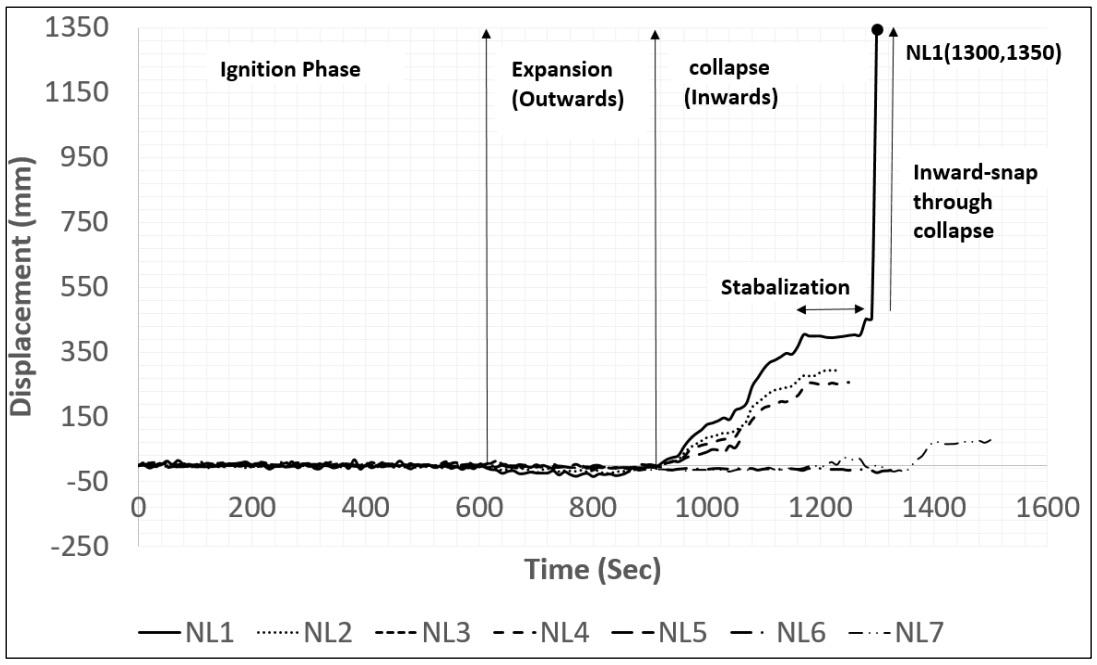
(b) Displacement verses time profile for northern side wall

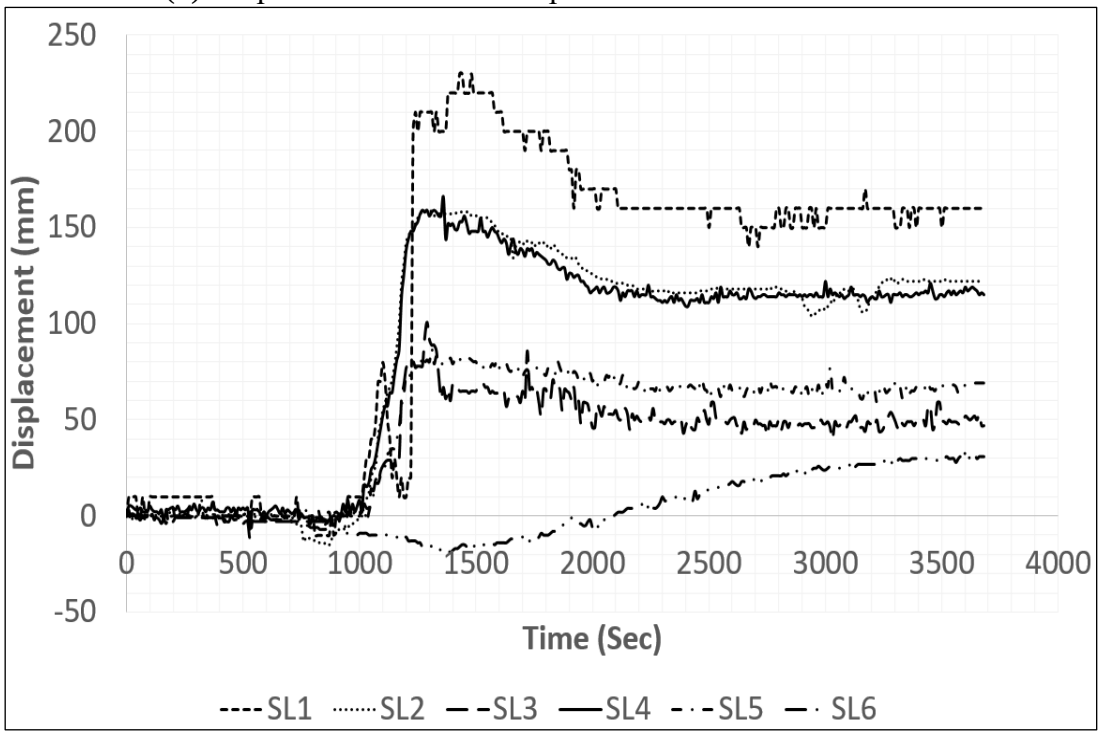
(b) Displacement verses temperature profile for southern side wall

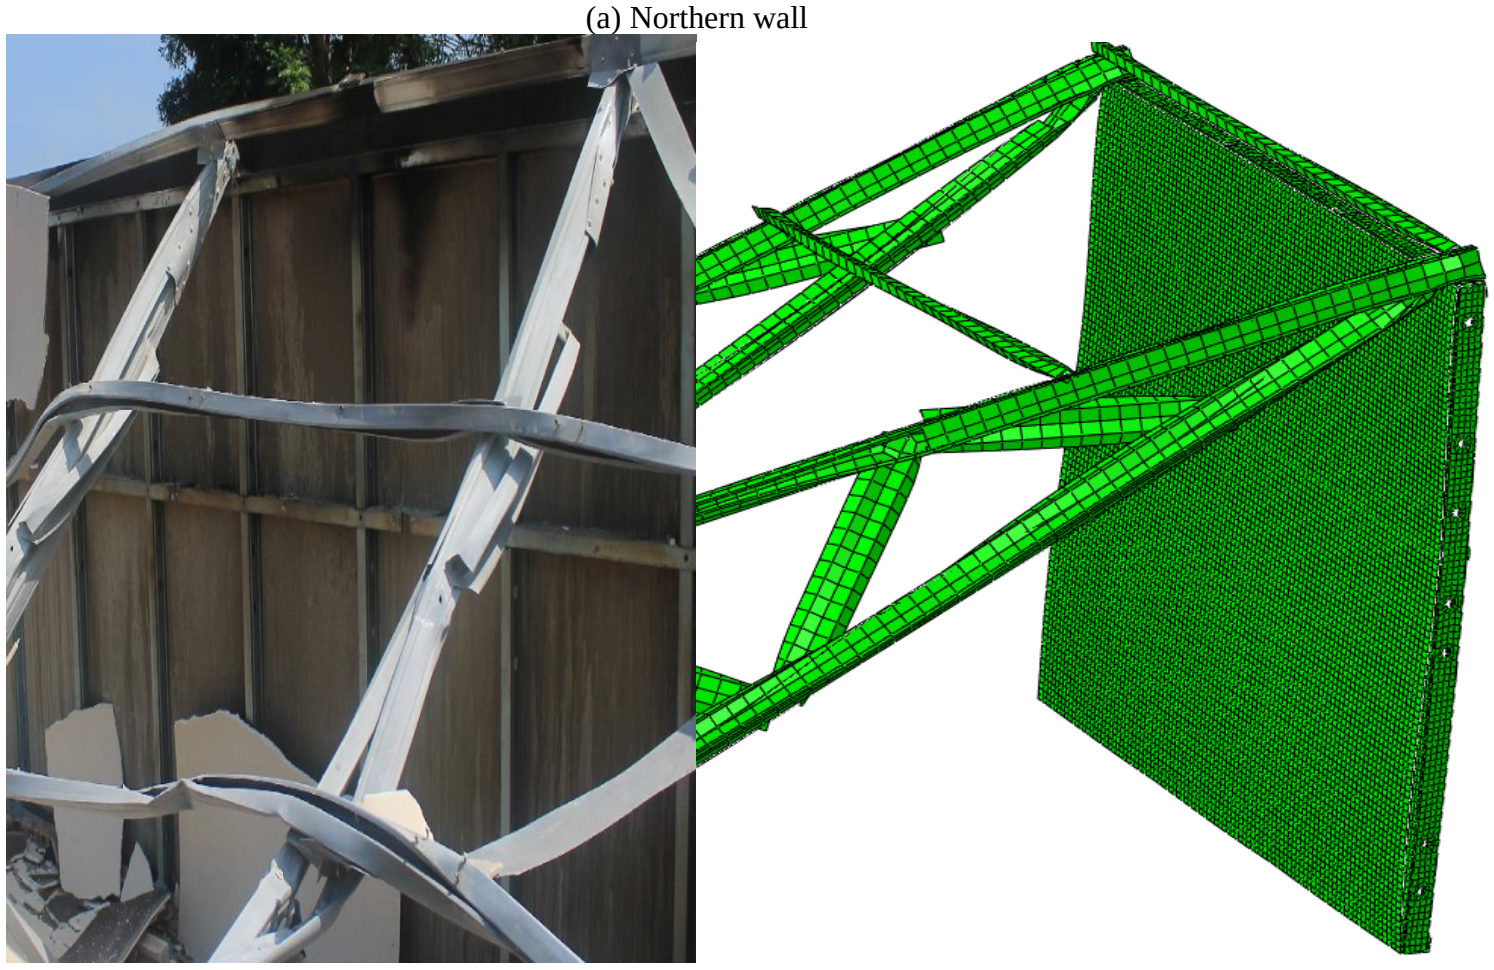
Fig. 19: Comparison of FEA and experimental failure modes

The side rails or the top, middle and bottom track played an important role in collapse mechanism of CFS building under fire. In the full-scale fire test, the top rail of northern side wall acted in tension which prevented the wall from out of plane collapse. However, the top rail buckled severely along their length due to being pulled by roof trusses during exposed to high temperature. Fig. 21(a) shows the flange of top rail at the corner was teared due to material degradation at high temperature. Thus, the top rail failed to provide lateral restraint to the wall studs. It was observed from the experiments that the failure of the walls were governed by the buckling of CFS member rather than failure of connections.

In the FE model, when the walls being pulled outwards by roof trusses due to thermal expansion, the top and mid rail temporarily provided lateral restraint to the compression flange. This is evident from the FE results where the thermal stresses are concentrated on the top rail and mid rail at 667 sec as shown in Fig. 21(b). The side rails had the tendency to prevent outward collapse by restraining the vertical CFS studs. However, the top and the mid rail failed to provide lateral restraint to the compression flange when the northern wall collapsed inward. Only the bottom rail provided lateral restrain to the north wall as it did not buckle severely.

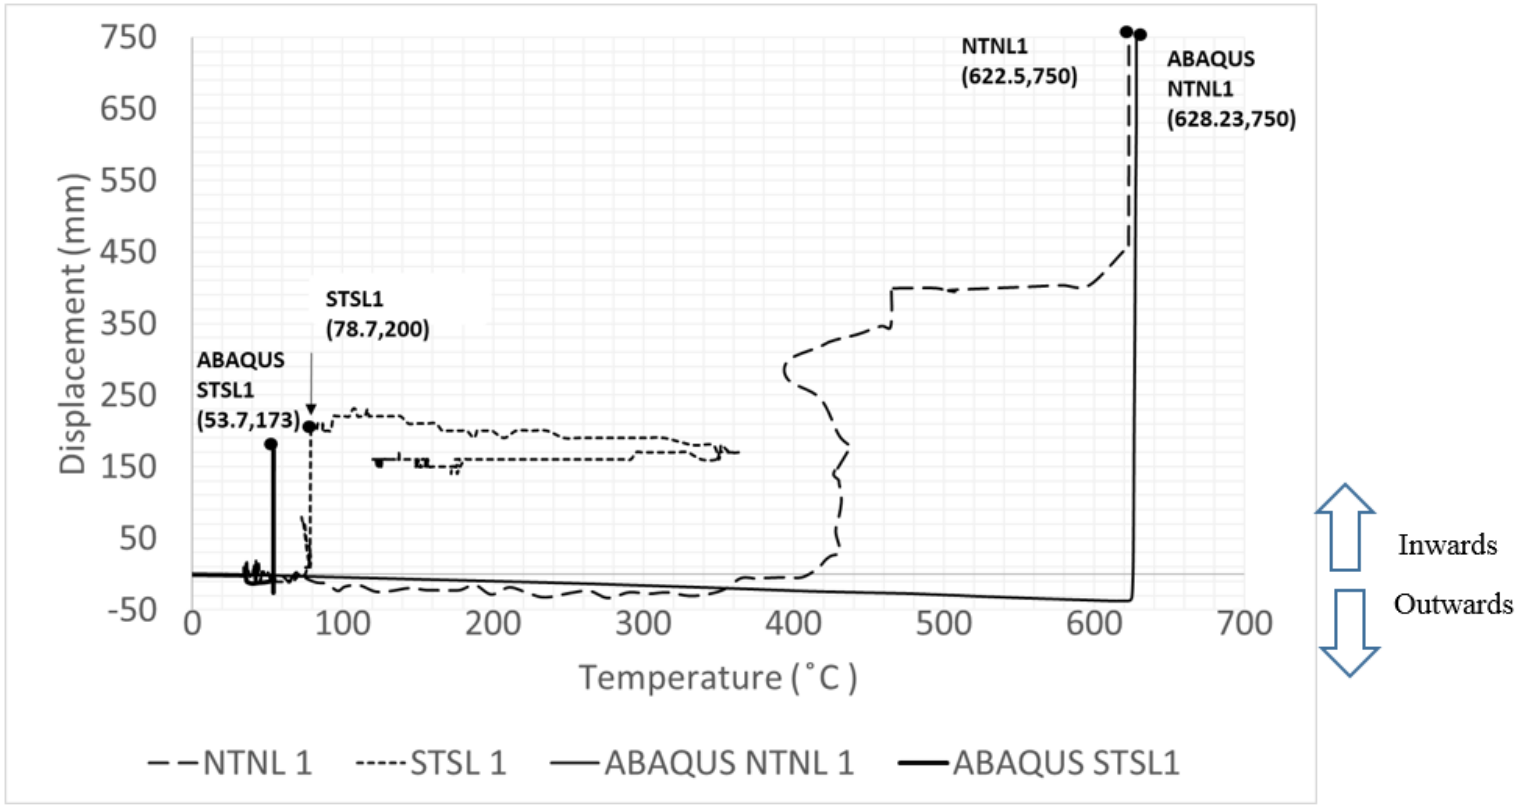
Fig. 20: Horizontal displacement against temperature graph

scale fire test at 622.5℃ and 22 minutes. On the other hand, the thermal and structural performance of cold-formed steel northern and southern side walls were assessed using temperature-displacement relationships. According to the results of FEA, snap-through buckling was formed at approximately one third from the top of the northern side wall with collapse temperature of 628.2℃ and 22 minutes while the temperature of south wall was 87℃ and able to withstand more than 22 minutes of fire severity. In Figs. 19(a) and 19(b), the failure modes from FEA were compared against the experimental failure modes for both northern and southern walls, respectively. On the other hand, horizontal displacements determined from the FEA, were plotted against the temperature in Fig. 20 for both the northern and southern walls.

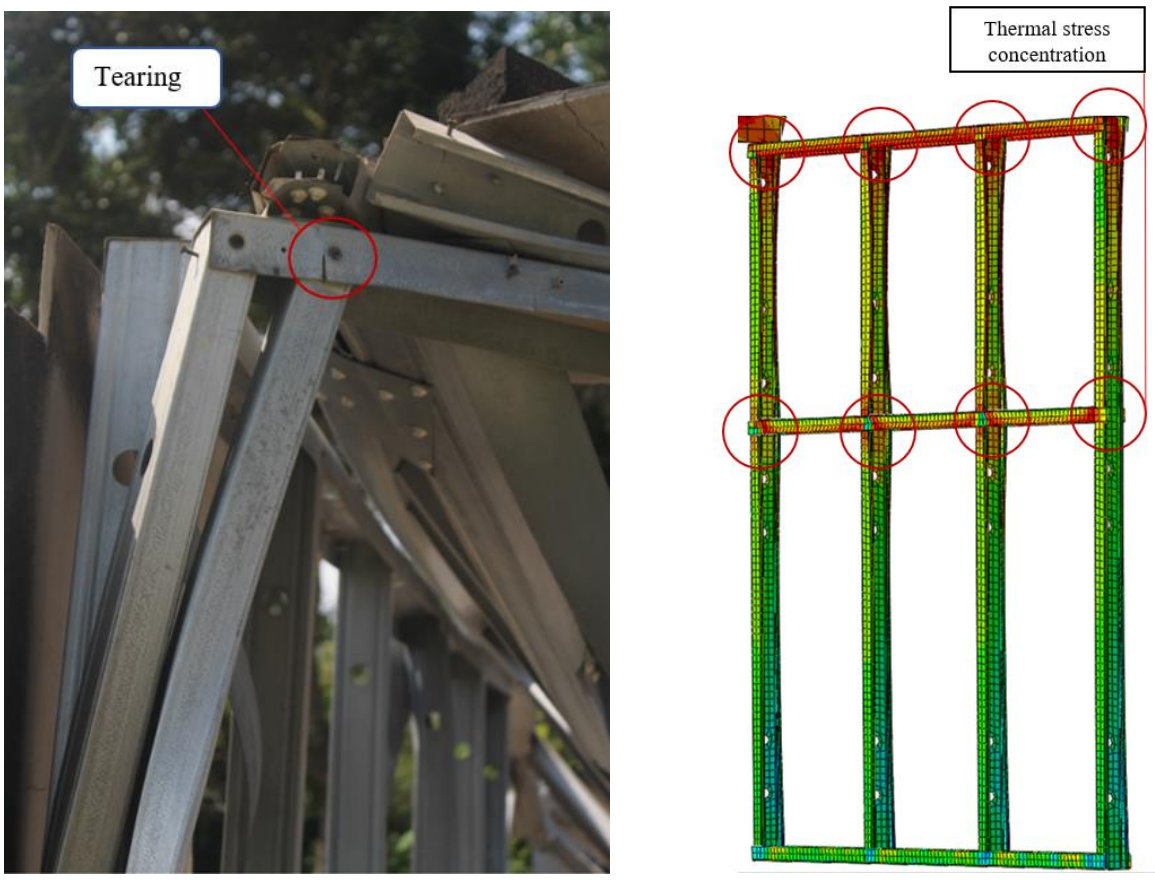
Fig. 21: Tearing failure and thermal stress concentration on the northern wall at 667 sec

(a) Experimental (Tearing failure) (b) FEA (Thermal stress concentration)
